Point Lay Housing Survey 2023

**Cold Climate Housing Research Center & National Renewable Energy
Laboratory**
955 Draanjik Drive,
Fairbanks, AK 99775

Point Lay Housing Survey

April 2023

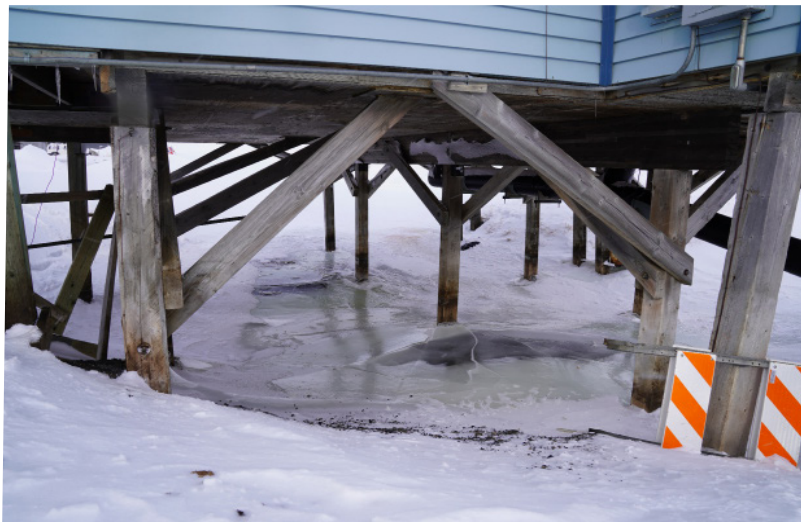
Figure 4. Frozen Pooled Surface Water Below Home. (NREL, 2022)

When water accumulates, it acts as a conductor and transfers more heat to the frozen ground below (Figure 4). This heat accelerates permafrost thaw and causes a positive feedback loop if not mitigated.

Water has accumulated under a house where subsidence has lowered the ground level. The water acts as a conductor, transferring more heat to the ground, and exacerbating the permafrost thaw.

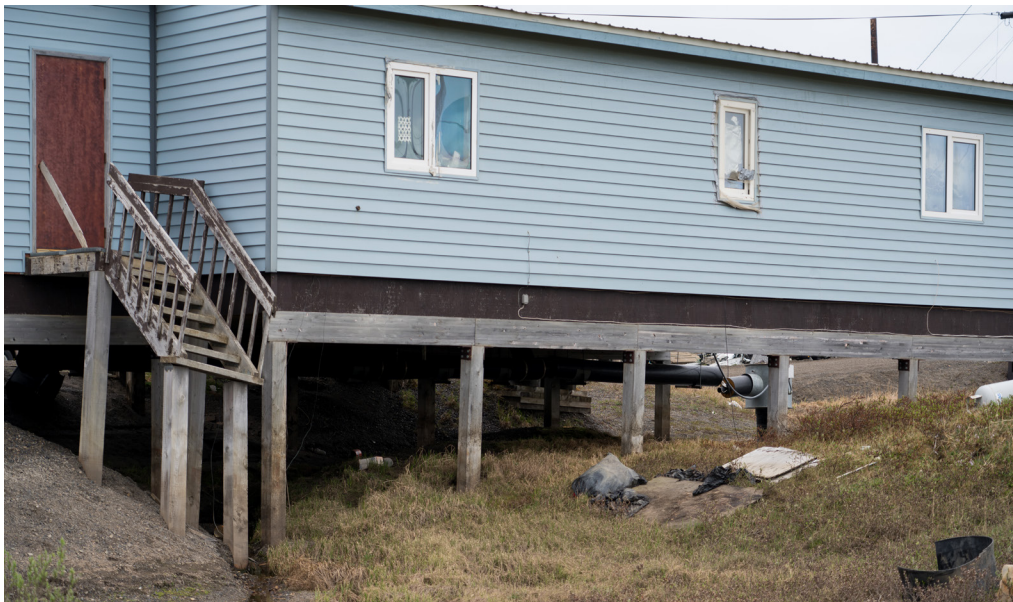
Figure 23. Example of Stair Conditions and Damage. (Point Lay Resident Bill Tracey, 2022)

Forty-four out of the 54 residential buildings (81%) reported the conditions of the stairs. Seventeen (39%) reported they were in good shape, 15 (34%) needed minor repairs, and 12 (27%) needed major repairs. These repairs could be varying degrees of damage or non-functioning aspects of the home, such as the stairs not meeting the ground, the materials being in bad shape, or something else that renders parts of the home dysfunctional or unsafe.

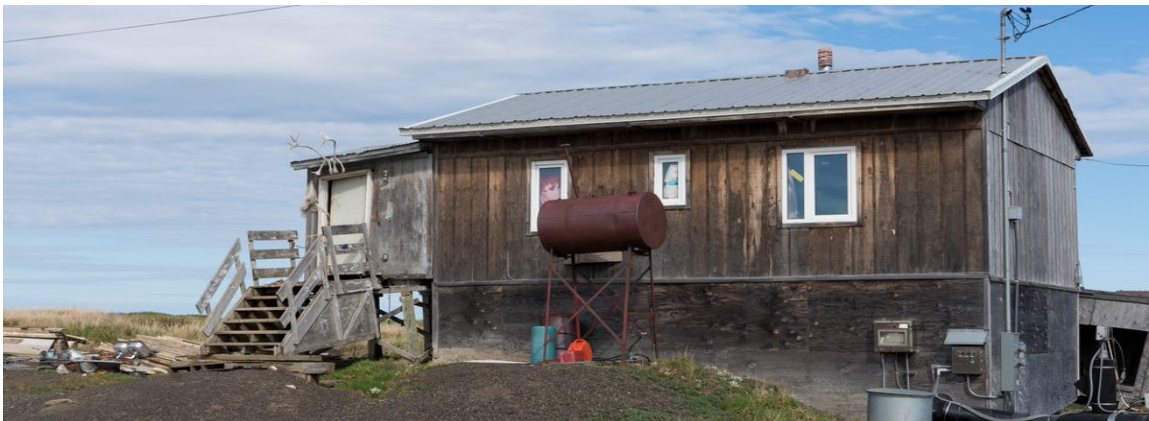
Figure 24. Example of Porch Conditions. (Point Lay Resident Bill Tracey, 2022)

Residents in 21 (38%) out of 54 residential buildings answered questions about the condition of the porch: 52% were reported to be in good condition, 19% needed minor repairs, and 29% needed major repairs.
