Point Lay Housing Survey 2023

**Cold Climate Housing Research Center & National Renewable Energy
Laboratory**
955 Draanjik Drive,
Fairbanks, AK 99775

Point Lay Housing Survey

April 2023

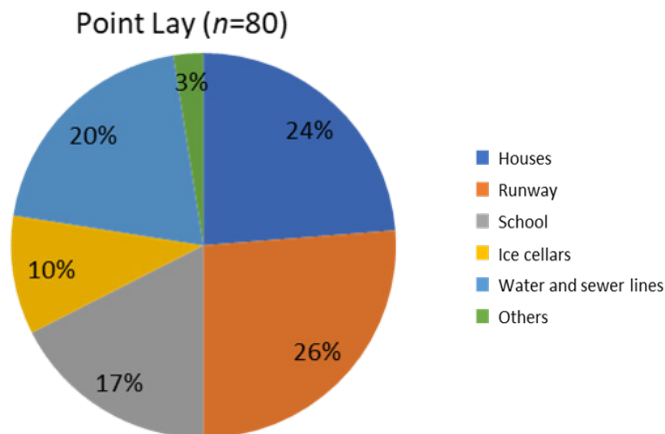
The survey respondents indicated that permafrost thaw also affected infrastructure such as the runway, school, ice cellars, and water and sewer lines. As with residences, these effects occurred between six months and more than 10 years before the survey was conducted.

Liew et al., Used with permission. Types of civil infrastructure that area affected by permafrost thaw. 2022.
